## Semarak International Journal of Applied Sciences and Engineering Technology

# Analytical Study of Temperature Rise in Cable Sealing End (CSE) Clamps

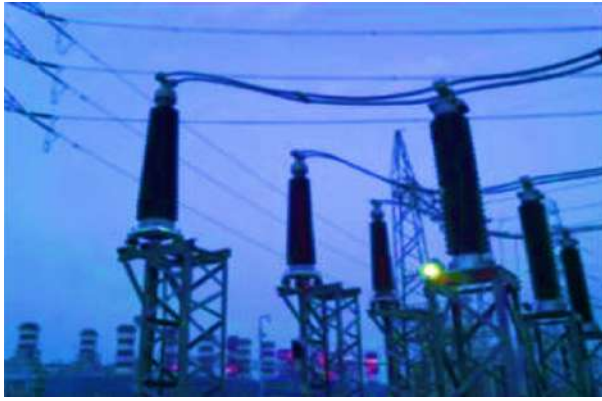
Temperature measurement using a thermography camera can be observed in Figure 1 and 2, which indicates a temperature delta of  $30^{\circ}\text{C}$  at the bushing. This delta temperature value falls within the critical condition category in accordance with IEC 62271-1:2017, which stipulates that the normal operating temperature limit should be  $\Delta T \leq 10 \text{ K}$ . Based on the findings from the temperature measurement, contact resistance testing was subsequently conducted, yielding a measured value of  $700 \mu\Omega$ . According to PT PLN (Persero) SE No. 0520-2.K/DIR/2014, the contact resistance for CSE components should be less than  $100 \mu\Omega$ , indicating that the obtained measurement value significantly exceeds the normal operating limit.

**Fig. 2.** The bushing being observed

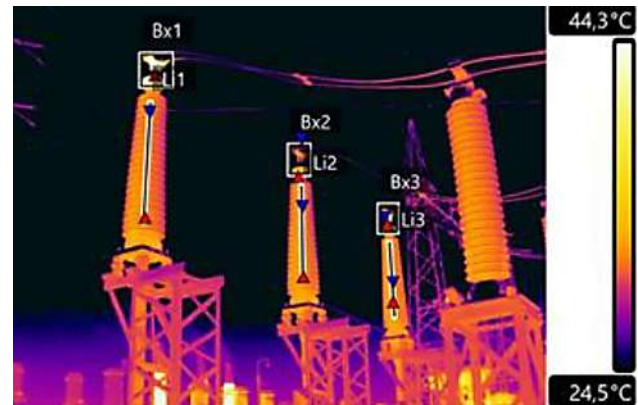
**Fig. 3.** Thermography measurement

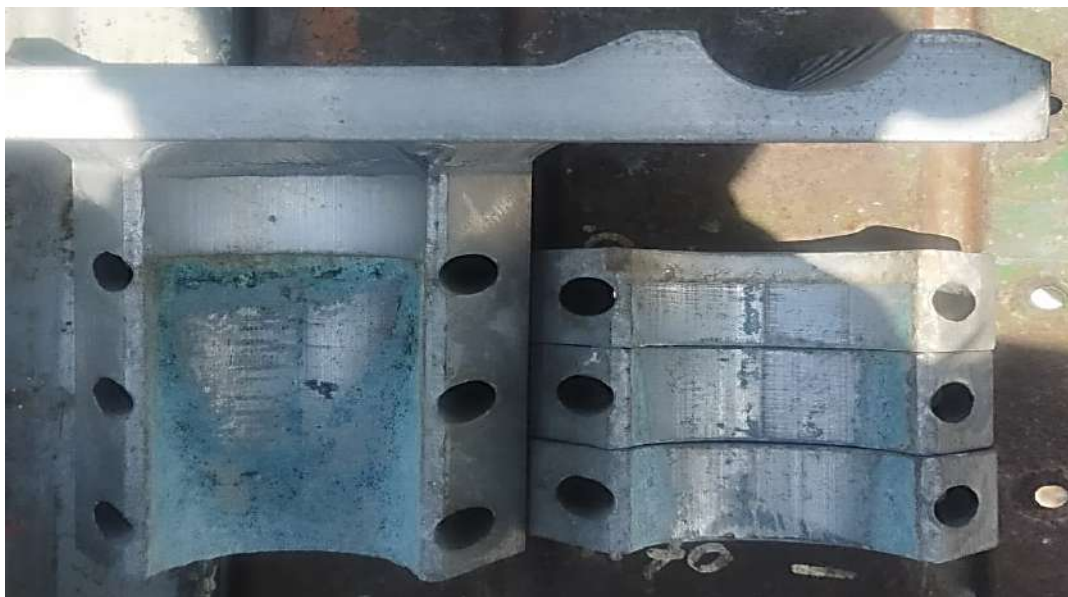
Further investigation was conducted through physical inspection of the component, revealing the presence of corrosion on the CSE clamp. Figure 3 illustrates the corrosion resulting from contact between the clamp and the conductor at the bushing, for which the corrective action taken was cleaning of both the clamp and the conductor at the bushing. It is this corrosion that constitutes the primary cause of the temperature rise observed at the CSE bushing.

**Fig. 4.** The clamp section that has corrosion

The Field investigations on the cable sealing end (CSE) clamp identified galvanic corrosion at the bimetallic contact interface between the aluminium conductor and the copper terminal as the principal factor driving the observed temperature anomaly. This electrochemical process, initiated by the potential difference between the two dissimilar metals in the presence of ambient moisture, causes aluminium to undergo progressive oxidation as the sacrificial anode, producing a non-conductive oxide layer composed primarily of aluminium oxide and aluminium hydroxide. The accumulation of this insulated layer at the contact interface elevates contact resistance over time, leading to disproportionate heat dissipation in accordance with Joule's Law and manifesting as a measurable hotspot condition at the clamp junction. Without intervention, this process becomes self-reinforcing, as rising temperatures further accelerate oxidation and corrosion, progressively compromising the mechanical and electrical integrity of the component and posing a risk of broader system disruption.

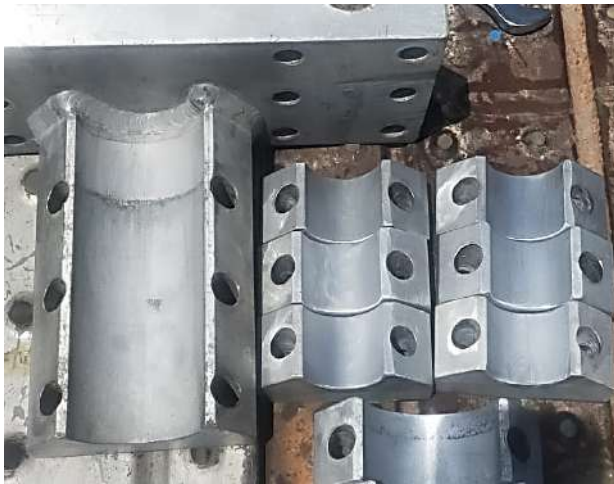
**Fig. 5.** The clamp that has been cleaned

As shown in Figure 4 and 5, the clamp component and conductor at the bushing have been cleaned of corrosion, after which retesting was conducted to verify that the component is operating within acceptable service conditions. Contact resistance was re-measured between the clamp and the conductor at the bushing to confirm a reduction in resistance value, with the expectation that the temperature at the CSE bushing would consequently decrease and the component would function properly. The contact resistance measurement results following cleaning indicated a reduction in resistance value to 60  $\mu\Omega$ , when referenced against PT PLN (Persero) SKDIR No. 0520-2.K/DIR/2014, falls within the acceptable normal operating limit of less than 100  $\mu\Omega$ .

Physical remediation through mechanical cleaning of the corroded clamp surface and bushing conductor confirmed that removal of the oxide layer produced a significant reduction in contact resistance, thereby validating the direct relationship between interfacial surface condition and component thermal behaviour. These findings underscore the necessity of implementing a structured and routinely scheduled maintenance programme for CSE components, incorporating thermography surveys, contact resistance testing, and physical inspection to enable early detection of abnormal conditions before they escalate into critical failures. Given the CSE's function as a transitional component between underground cable systems and high-voltage substation equipment, degradation at this point carries implications for overall system reliability. A condition-based maintenance approach, guided by quantitative field data and validated against applicable technical standards, therefore represents the most effective strategy for sustaining the long-term operational performance of the power system.

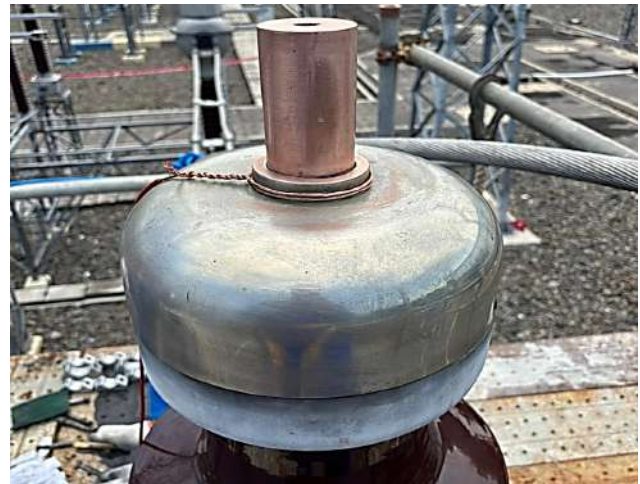
**Fig. 6.** The bushing conductor that has been cleaned
