Analysis of Boiler Operations in the Engine Room Laboratory of Makassar Maritime Polytechnic for Recertification by the Occupational Safety and Health Office of the Department of Manpower

This study analyzes the feasibility and operational safety of boilers at the PIP Makassar Engine Hall Laboratory as part of recertification efforts through the integration of technical testing directly supervised by the Ministry of Manpower's Occupational Safety and Health Authority. The novelty of this study lies in its empirical validation through three stages of systematic testing—visual inspection, hydro test, and pressure test—to ensure that maritime education safety standards are met. The test results show that the boiler is structurally recommended for operation because the safety valve functions optimally by opening at a pressure of 5 kg/cm². However, through the hydro test procedure up to a pressure of 7 kg/cm², critical weaknesses were found in the form of leaks in the manhole packing, two check valves, and two filling pump valves. These findings provide practical contributions in the form of identifying specific points of failure that require immediate repair and chemical maintenance b

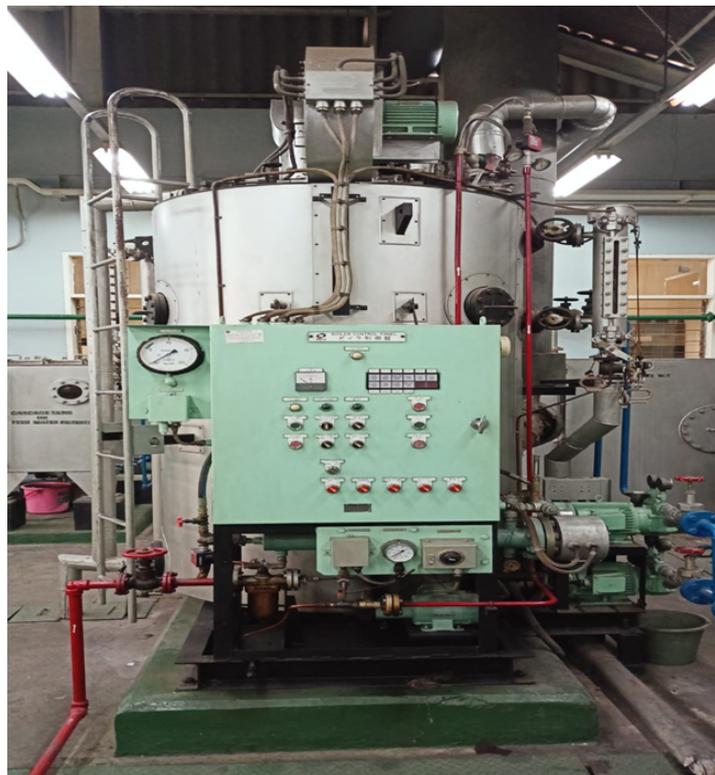
Fig. 1. Boiler in the Engine Hall Laboratory

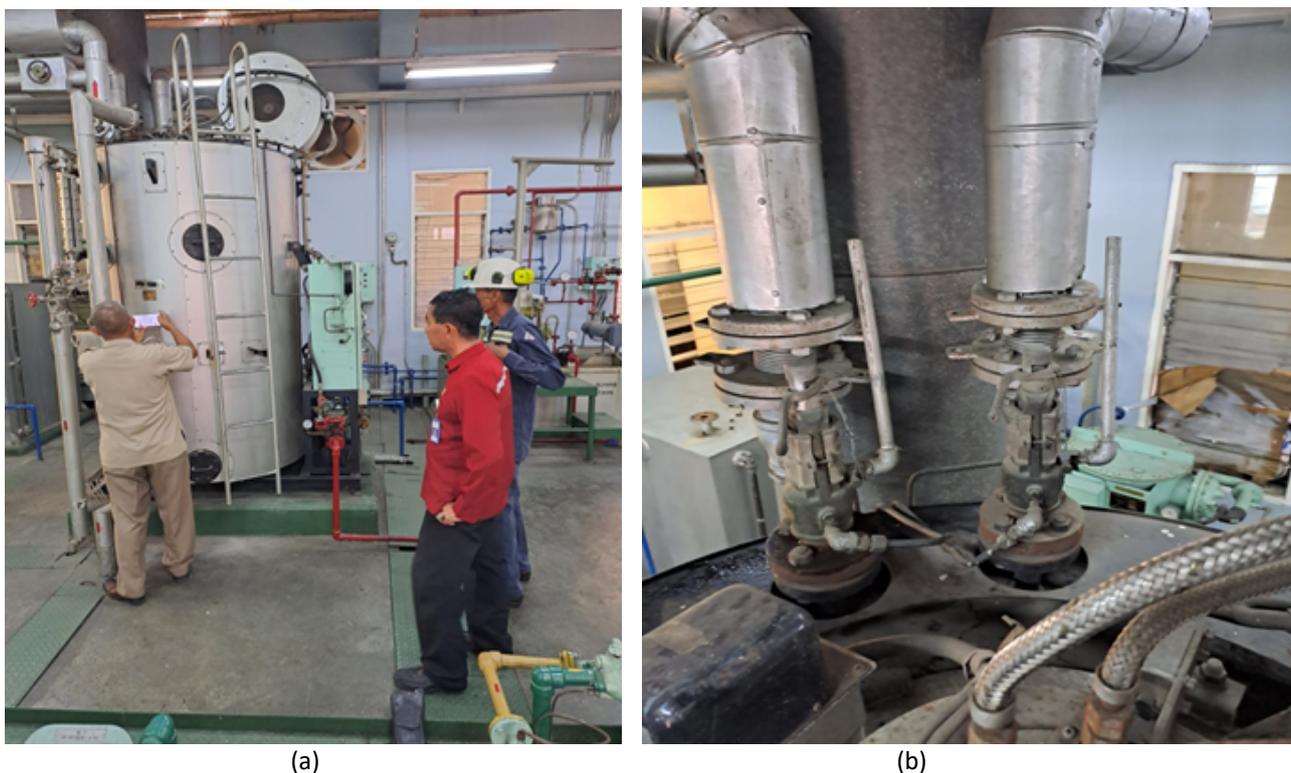
Before conducting experimental testing, a visual inspection is performed. Visual inspection means inspecting equipment and structures using a combination of human senses such as sight, hearing, touch, and smell [15]. Visual inspection is the most basic of the various non-destructive testing control methods, but it is no less important. The disadvantage of the visual inspection method is that it can only detect defects on the surface of the test material and can only detect defects that are visible to the naked eye or with optical aids. Figure 2(a) shows A visual inspection has been carried out at a place that can be seen and reached, and it was found that there was mud that was easy to fall off. It is recommended to clean it by spraying clean water. After that, the boiler can be prepared for hydro testing.

Fig. 2. (a) Visual inspection of boilers, (b) Compression test, pressure 2 - 4 kg/cm²

A pressure test was also conducted on the boiler to observe and determine whether the safety valve was still functioning properly. This test was absolutely necessary to prevent an explosion. Figure 2(b) shows the top of the boiler with two safety valves installed on the pipe, along with a note that at pressures between 2 kg/cm² and 4 kg/cm² the safety valves remain closed, indicating that the set pressure of the safety valves is higher than 4 kg/cm². Safety valves are designed to automatically release excess pressure from the boiler to prevent dangerous structural failure. If the test pressure has reached 4 kg/cm² and the valve remains closed, this means that the maximum safe point of the boiler specified by the designer is above that value. The boiler design specifications need to be re-verified to determine the maximum allowable working pressure (MAWP) and the actual safety valve opening pressure. The pressure test procedure is usually carried out to ensure the structural integrity of the boiler and to test the function of the safety valve.

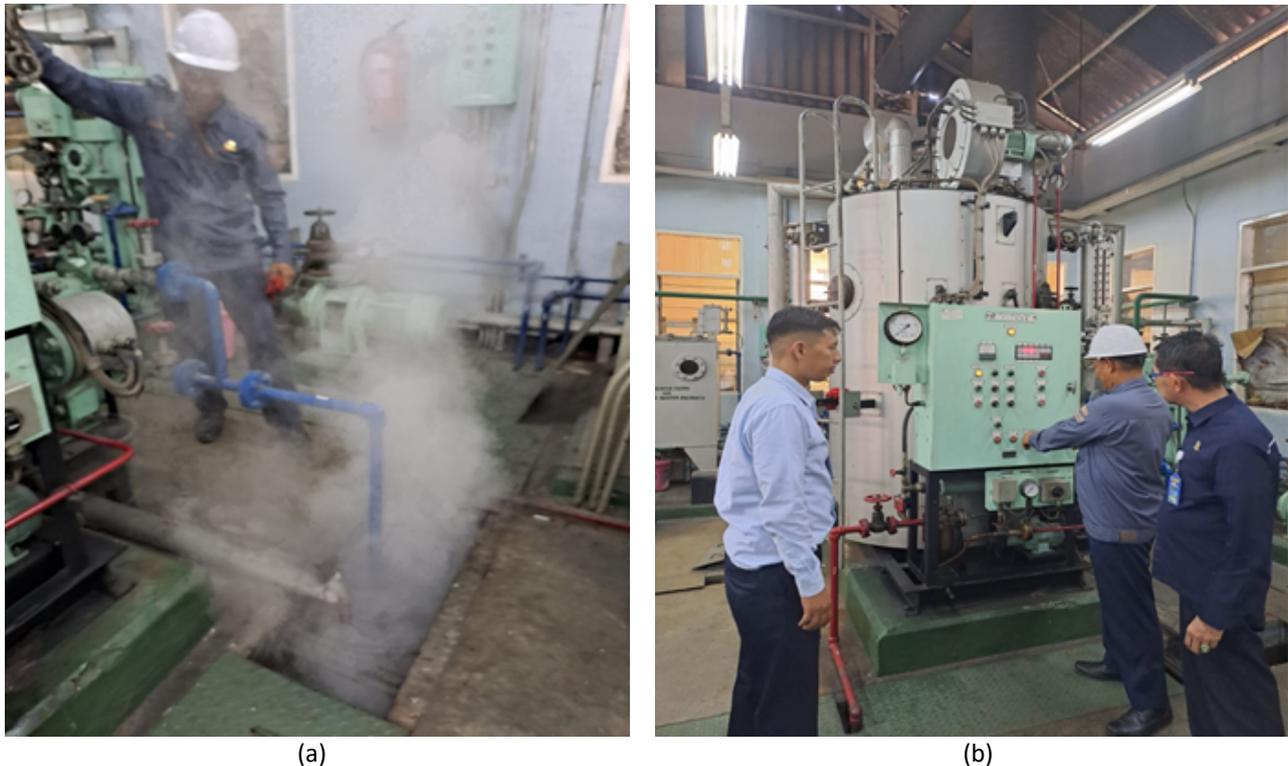
Fig. 3. Pressure testing, pressure reaches 5 kg/cm^2 , (b) Pressure 1 kg/cm^2 , safety valve: close and no leaks

Figure 3 (a) shows a situation where steam is billowing heavily, and explains that this is part of a Pressure Test on a Boiler where the safety valve opens at a pressure of 5 kg/cm^2 , indicating that the set pressure of the boiler safety valve has been set at or slightly below 5 kg/cm^2 . The main purpose of a safety valve is to automatically release excess pressure to prevent boiler damage and potential explosion hazards if the internal pressure exceeds the safe limit. The opening of the valve at this pressure indicates that the safety valve is functioning properly according to its settings and has successfully secured the system by releasing high-pressure steam into the atmosphere. The steam seen billowing in the photo is the result of the safety valve releasing excess pressure. The released steam will be extremely hot and pressurized, requiring a safe discharge channel (commonly referred to as a vent or blow-off pipe), such as the blue pipe visible in the area, to direct it to a safe location away from workers or sensitive equipment. Testing the safety valve is very important and is often carried out as part of mandatory maintenance or inspection to ensure that the boiler operates within specified safety limits and that this most important pressure protection device is ready to respond to unexpected overpressure conditions during normal operation.

Figure 3 (b) shows a hydro test (hydrostatic pressure test) conducted on a boiler (steam boiler). This test is an important safety and structural integrity procedure to ensure that the pressure vessel (in this case, the boiler) is capable of withstanding the specified working pressure without leakage or permanent deformation. The fact that the boiler did not leak at a pressure of 1 kg/cm^2 is a good initial indication that the welded joints, gaskets, and boiler body materials are in adequate condition at the test pressure. However, 1 kg/cm^2 (1 bar or 14.22 psi) is very low for a standard hydrostatic test of an industrial boiler; typically, hydrostatic tests are performed at much higher pressures, usually 1.25 to 1.5 times the Maximum Allowable Working Pressure (MAWP), to provide an adequate margin of safety against operational pressures. Test results indicating no leakage at 1 kg/cm^2 show that the boiler passed the test at that pressure. Procedurally, this test involves filling the boiler with water to capacity and then gradually increasing the pressure using a test pump until the required test pressure is reached. Careful visual observation must be made of all joints, welds, manholes, and handholes during the pressure holding period to detect even the smallest seepage or leak.

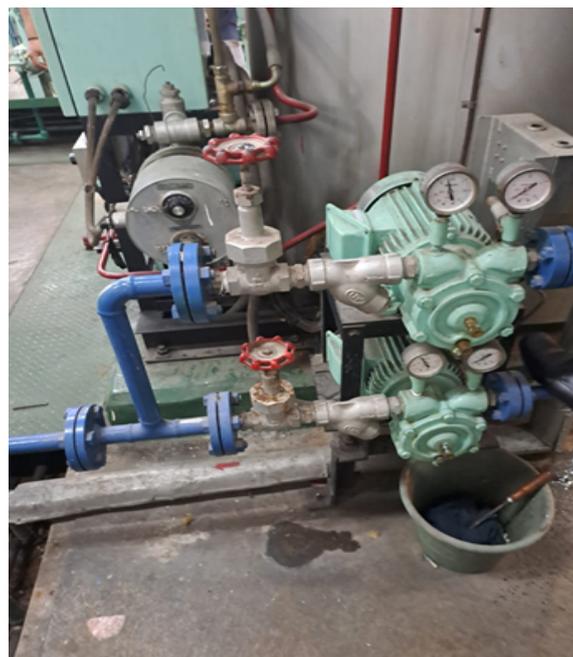
Fig. 5. Result of test pressure $3 - 7 \text{ kg/cm}^2$

Figure 5 shows the results of the Hydrostatic Pressure Test (Hydro Test) on the boiler, which failed due to leaks in two filling pump valves (Pump 1 and Pump 2). These valves, which appear to be globe valves (valves with red handwheels), serve to isolate or regulate the flow of water entering the boiler during normal operation, and are also critical during hydro tests to maintain the integrity of the feed water system. Leaks in these valves, most likely occurring in the valve stem gland packing or flange connection, caused the observed drop in water pressure. This pressure drop indicated that the system was unable to withstand the required test pressure, thereby failing the hydro test.

Failures caused by leaks in the filling pump valves mean that the boiler cannot be certified as safe until this problem is fixed. To fix this, the leaky valves need to be repaired, which might involve tightening or replacing the valve stem packing (re-packing), or disassembling and repairing/replacing the flange packing on the leaky connection. Since there are two leaking valves from two different pumps, it is important to check the condition of all similar valves in the system. Once the physical repairs to both valves are complete, the hydro test must be repeated from the beginning. A successful retest (i.e., the boiler can maintain the specified test pressure without a drop) is essential to verify the integrity of the system's seals and ensure the future operational safety of the boiler.
