Semarak International Journal of Design, Built Environment and Sustainability

Slope Factor of Safety Assessment using Spectroradiometer Data and Unmanned Aerial Vehicle Imagery

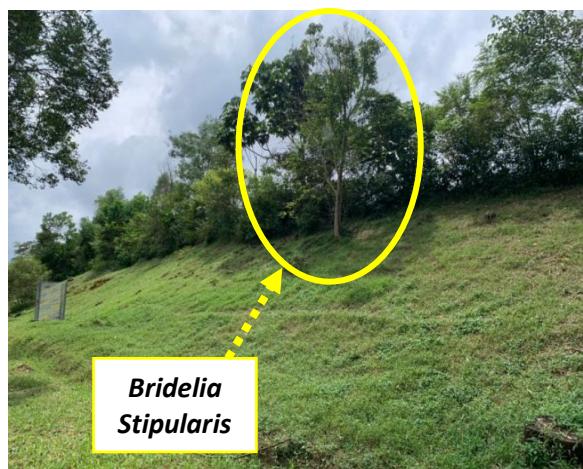
The study was conducted at Dusun UTM, located on the middle of the slope at coordinates (N 1.5642°, E 103.6253°) as shown in Figure 1. Previous study have shown the site is characterized by tropical climatic conditions with frequent rainfall and sandy silt soil [33,34]. A single *Bridelia Stipularis* tree located at the midpoint of the slope was selected due to its prominent position and potential influence on slope hydrology and mechanics. The slope was monitored for changes in soil water content and stability.

Fig. 1. *Bridelia Stipularis* tree located at the middle of slope Dusun UTM

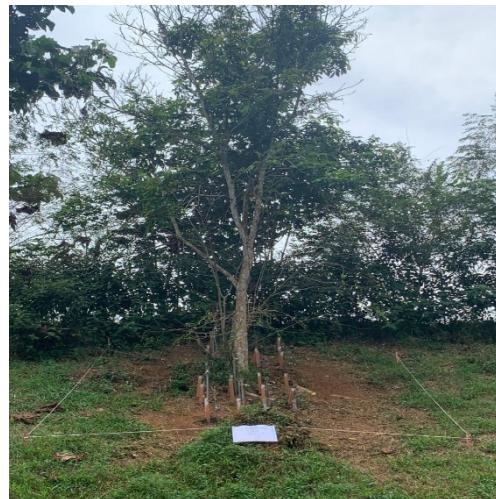
Tensiometers and gypsum blocks were installed at different depths of 0.5 m, 1.0 m, 1.5 m, and 2.0 m along the critical slip surface to monitor soil matric suction. Rain gauges were also used to quantify precipitation, enabling the correlation between rainfall events and changes in suction. This monitoring is to observe how transpiration-induced suction from the tree influences slope stability [35]. Figure 2 displays the tensiometers and gypsum blocks installed at the slope area.

Fig. 2. The installation of tensiometers and gypsum blocks at slope area

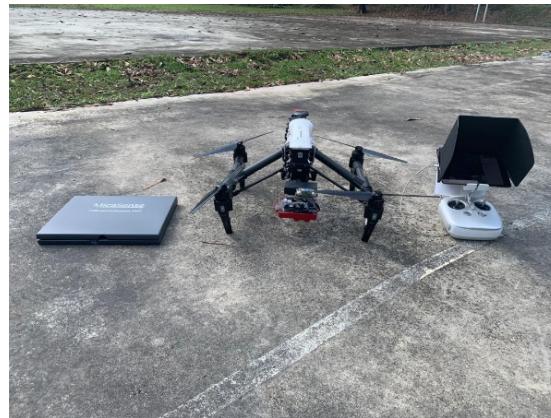
Several essential pieces of equipment, as shown in Figure 3, are required for this study, comprising a full set of commercial unmanned aerial vehicles (UAV). This includes the DJI Inspire 1 UAV equipped with a Micasense camera, remote controller and MicaSense calibration panel case. According to Vishweshwaran and Sujatha [36], the UAV derived digital surface models (DSM) and orthophotos were validated using ground control points (GCPs) collected through Real Time Kinematic Global Positioning System (RTK GPS) surveys. A series of well distributed GCPs were established across the study area to ensure accurate georeferencing and alignment of the UAV imagery. The coordinates of these points were measured with a positional accuracy of less than 5 cm, serving as reference markers for correcting spatial distortions during the photogrammetric processing stage. The accuracy of the final DSM and orthophotos was further evaluated by comparing the UAV derived coordinates with the RTK GPS GCP data, confirming high spatial reliability suitable for terrain analysis and slope stability assessment.

Fig. 3. DJI Inspire 1 UAV

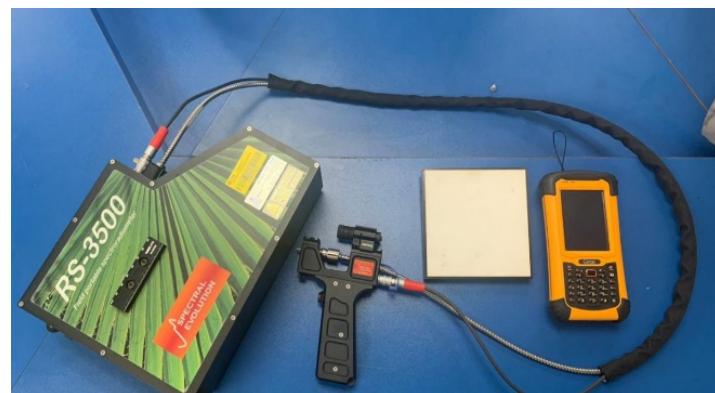
Figure 4 shows the Spectral Evolution (RS-3500) and its accessories, which include a pistol grip and white reflectance. It can be used to detect wavelengths from 350nm to 2500nm. The reading of the spectroradiometer was recorded by a data logger using the Getac model.

Fig. 4. Spectral Evolution (RS-3500) and its accessories

Spectroradiometer readings were calibrated using a white reference panel before each measurement to minimize reflectance error and ensure data consistency are taken from previous study [37,38]. Prior to data acquisition, the instrument's sensor was first dark-calibrated to account for internal electronic noise, followed by calibration with a standard white reference panel to establish a baseline for 100 percent reflectance. This procedure was repeated periodically throughout the field campaign to compensate for changes in ambient light conditions, such as variations in solar angle or cloud cover. By performing both dark and white reference calibration, the accuracy and reliability of the spectral reflectance measurements were maintained, enabling precise calculation of vegetation indices (VI) used in the analysis.

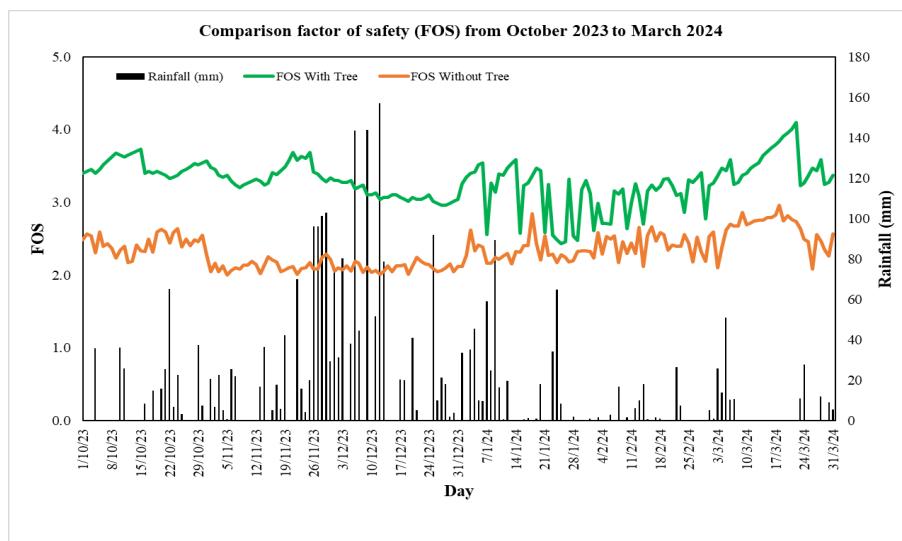
Figure 5 compares the factor of safety (FOS) between slopes with and without trees from October 2023 to March 2024. This provides us with the required information about the stability of slopes. According to the conventional geotechnical standards, the FOS value that is greater than 1.0 is generally considered stable, while values less than 1.0 indicate potential instability and a high risk of failure [39].

During the monitoring period, the slope with a tree consistently showed greater stability than the slope without a tree, as shown by consistently higher FOS values. The tree (*Bridelia Stipularis*) had a significant buffering effect against FOS reductions during rain events, and both scenarios stayed the same. The data showed that both slopes' FOS values changed during the periods of moderate to heavy rainfall (up to 160 mm). These higher values were associated with FOS values between 3.0 and 4.0, indicating more stable slope conditions.

Fig. 5. Comparison of factor of safety (FOS) for slopes with and without a tree at the middle of the slope from October 2023 to March 2024

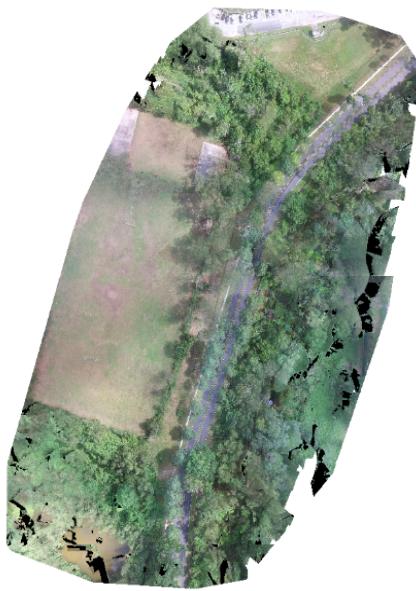
The captured high-resolution imagery underwent comprehensive photogrammetric processing, resulting in the generation of detailed spatial products for the Dusun UTM slope. These products included a georeferenced digital orthophoto, which provided a precise planimetric representation of the study area, as shown in Figure 6. A digital surface model (DSM) that accurately depicts the terrain elevation and surface features is shown in Figure 7.

Fig. 6. Digital orthophoto from UAV digital mapping at Dusun UTM

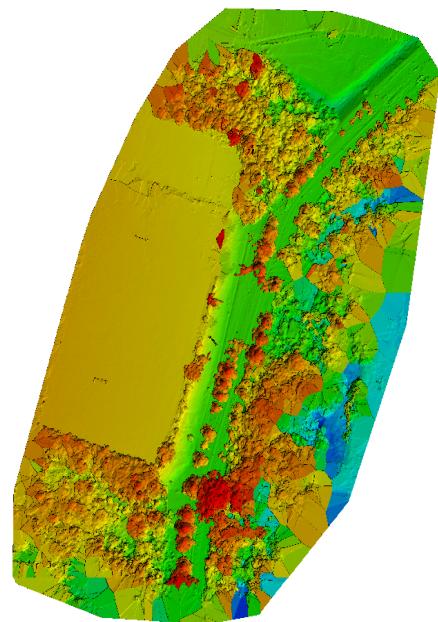
Fig. 7. Digital surface model (DSM) from UAV digital mapping at Dusun UTM

The three-dimensional (3D) visualization of Dusun UTM was generated using Pix4D Mapper. This 3D representation was derived from the processed UAV data, enabling detailed visualization of the study area's complex topography, including variations in terrain. Table 1 presents the measurement of the slope of Dusun UTM, including the feature type and its respective measurements.

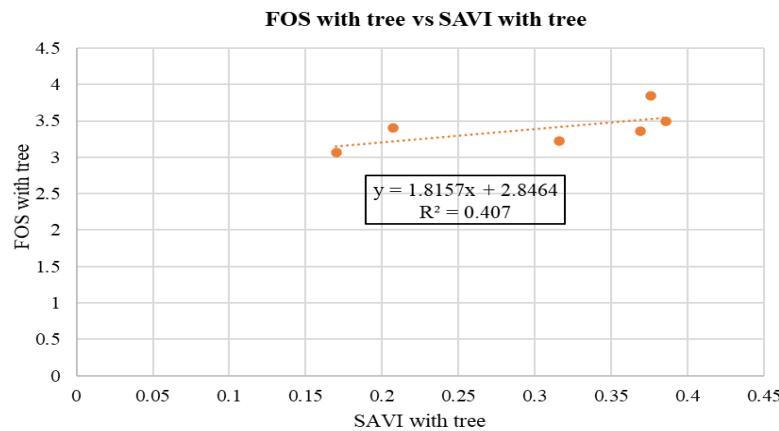
The relationship of the factor of safety (FOS) with vegetational indices (VI) is analyzed further in Figures 8. Figure 8 exhibited a proportional linear correlation between FOS with a tree and SAVI with a tree. As SAVI with the tree increased, FOS with tree also increased, indicating that higher vegetation cover with tree contributed to more excellent slope stability. The trendline was defined by the equation $y = 1.8157x + 2.8464$, meaning that this positive slope indicated a direct correlation between FOS with a tree and SAVI with tree. The R^2 value was 0.407, suggesting that 40.7% of the variability in FOS with tree could be explained by SAVI with a tree, indicating a moderate relationship between FOS with tree and SAVI with tree.

Fig. 8. The relationship between factor of safety (FOS) with tree and the Soil Adjusted Vegetation Index (SAVI) with tree

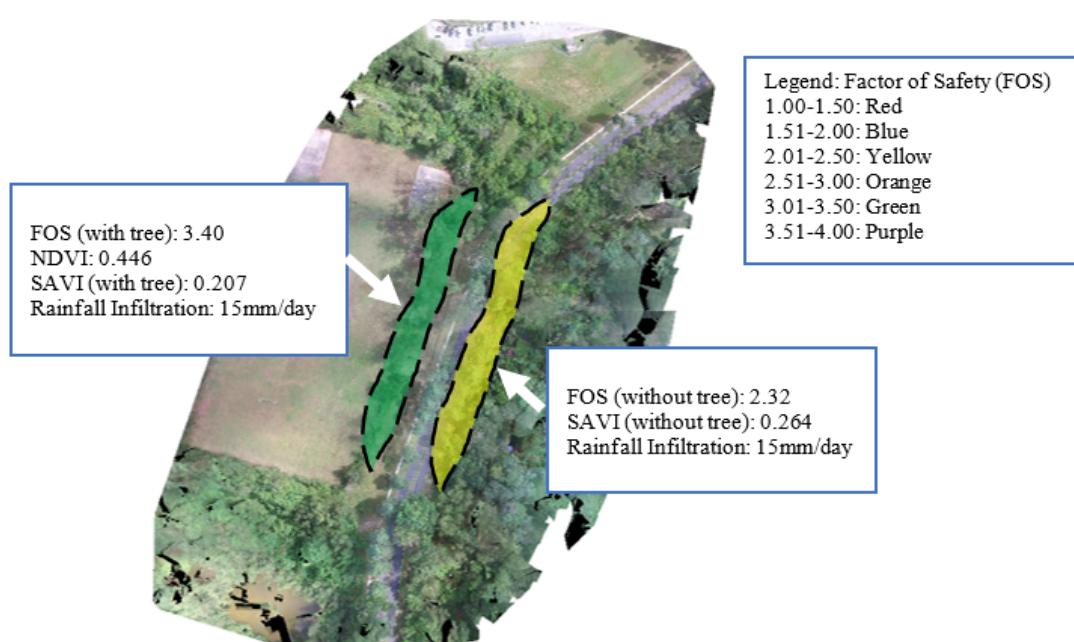
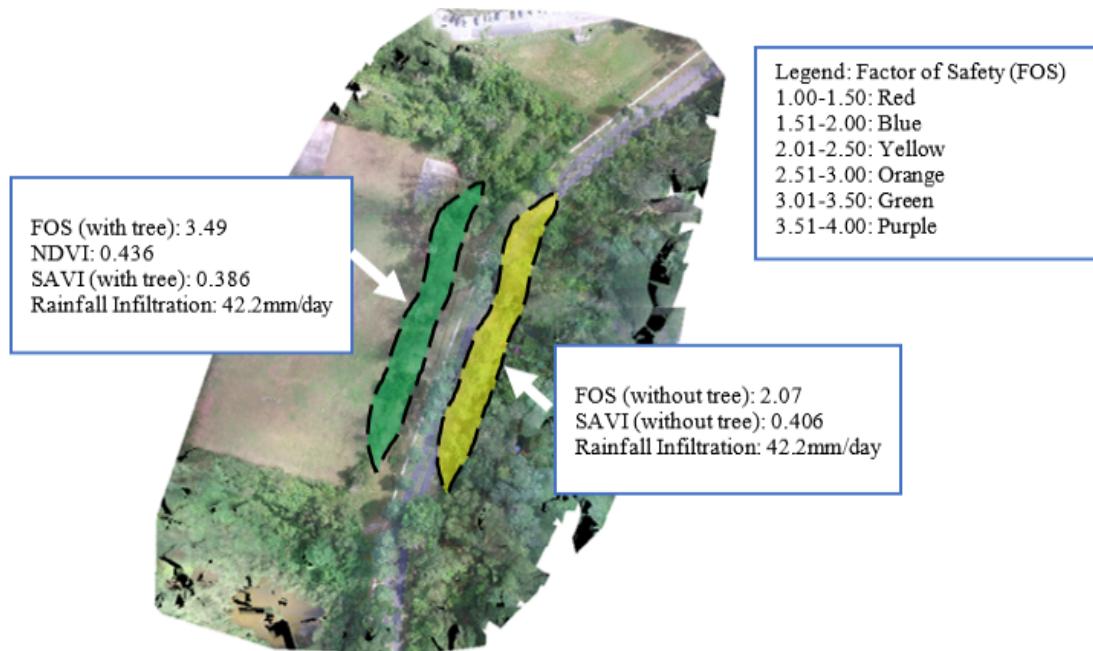
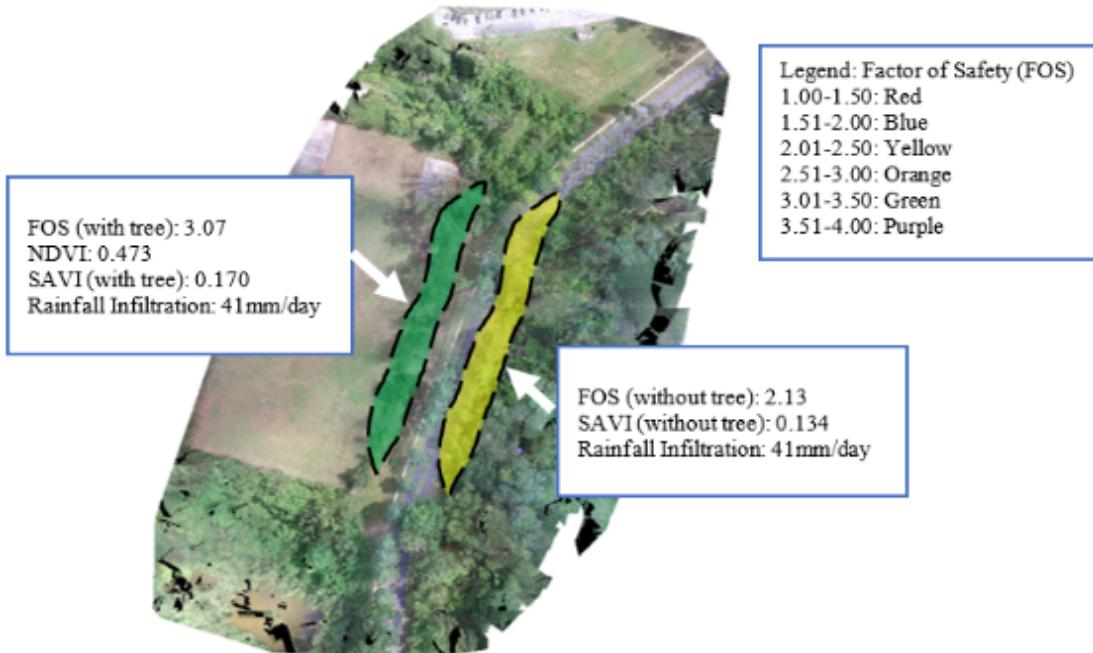
The safety values and vegetation indices (NDVI and SAVI) for the six selected dates were applied to the map of Dusun UTM, which had been generated earlier using an unmanned aerial vehicle (UAV). These safety maps were presented under two conditions: with and without a tree. All the maps are shown in Figures 9 through Figure 14.

During the wet season, the factor of safety (FOS) for slopes with trees remained consistently within the range of 3.01–3.50 (green) over three consecutive months. Despite increased rainfall and a higher risk of slope instability, these tree-covered slopes maintained stable FOS values, indicating that vegetation effectively buffered the impact of rainfall. This stabilization is a result of transpiration-induced suction, which decreases the pore water pressure and canopy interception that prevents direct rain from reaching the soil surface and root reinforcement, which strengthens soil cohesion and stops mass movement. Otherwise, slopes without trees consistently showed lower FOS values, which ranged between 2.01 and 2.50 (yellow), indicating marginal stability. These conditions showed that without vegetation, slopes are more directly affected by hydrological stress, which leads to an increase in moisture levels and a decreased of the soil shear strength, thus raising the risk of failure, especially during intense rainfall.

Fig. 9. Factor of safety (FOS), vegetation indices (VI) and rainfall data on 18th October 2023

Fig. 10. Factor of safety (FOS), vegetation indices (VI) and rainfall data on 19th November 2023

Fig. 11. Factor of safety (FOS), vegetation indices (VI) and rainfall data on 20th December 2023

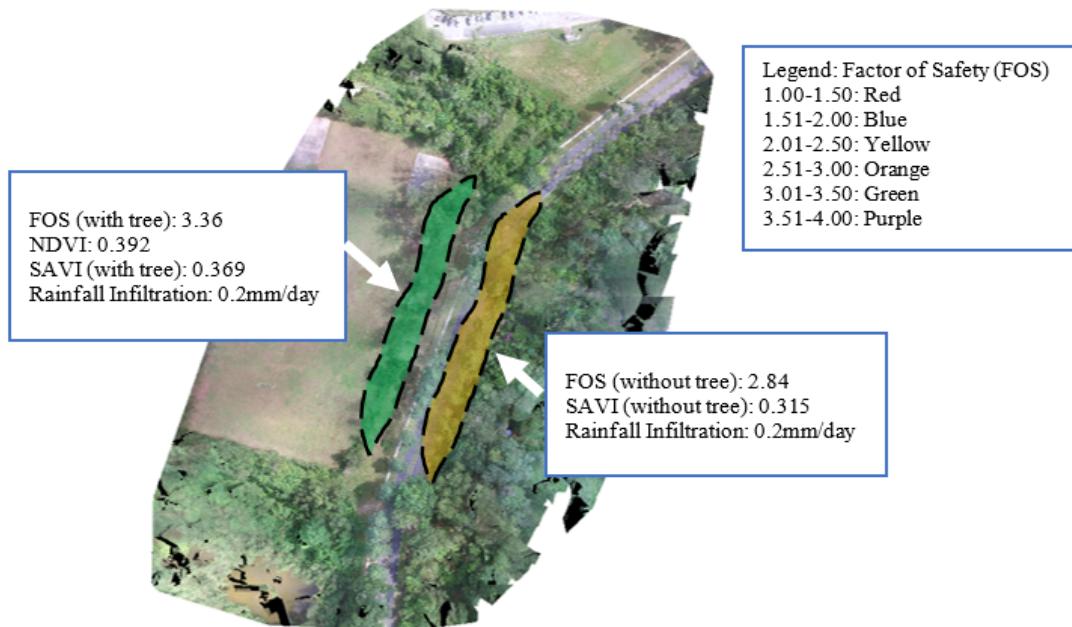
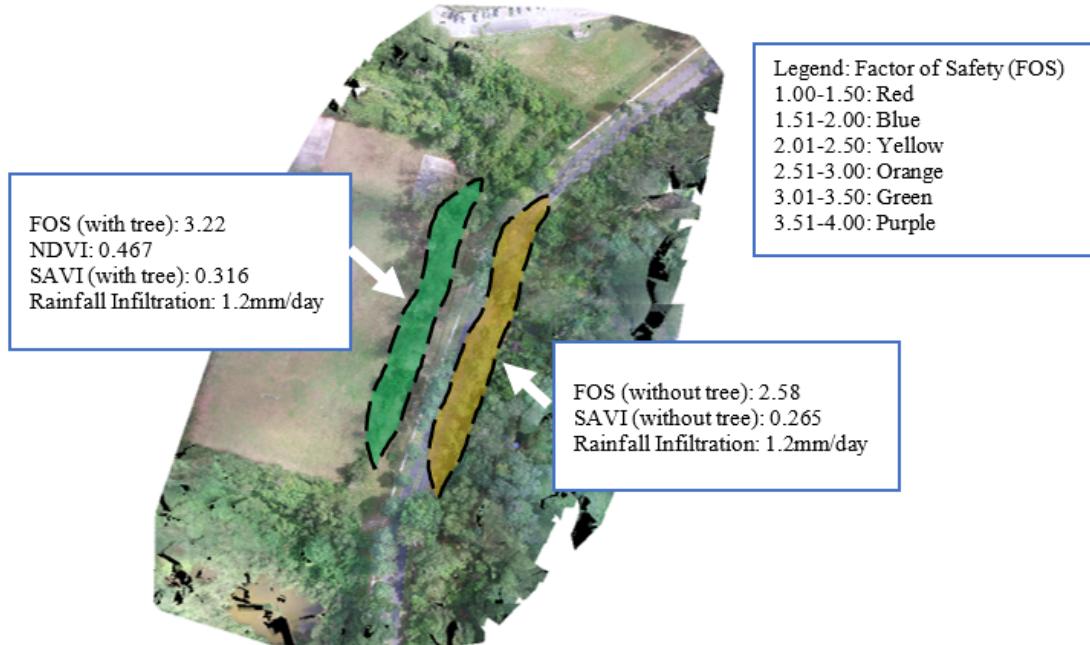
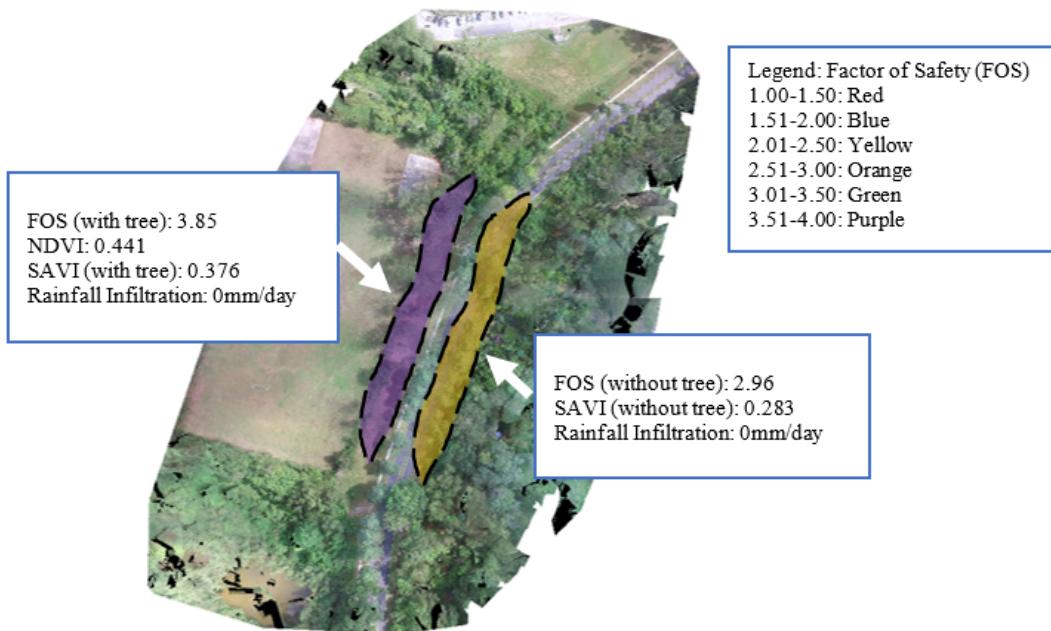
In the dry season, the FOS for slopes with trees remained stable at 3.01–3.50 (green) in January and February 2024, consistent with the wet season values, indicating that the stabilizing benefits of tree-induced suction and root reinforcement persist even with minimal water input. The FOS showed an increase again by March 2024, reaching a range between 3.51–4.00 (purple), which is the highest recorded range. This showed that soil moisture levels dropped even more because of the continued transpiration and evaporation by the vegetation, and it also shows that the slope condition is even more stable, with a very low risk of failure. This improvement also highlights the cumulative effect of vegetation over time in enhancing soil structure and strength. In contrast, slopes without trees showed a slight improvement compared to the wet season, with FOS values rising to 2.51–3.00 (orange), likely due to the natural reduction in pore water pressure under drier conditions. However, these slopes remained significantly less stable than those with vegetation, emphasizing that natural drying alone cannot match the effectiveness of tree cover in reinforcing and stabilizing slopes.

Fig. 12. Factor of safety (FOS), vegetation indices (VI) and rainfall data on 18th January 2024

Fig. 13. Factor of safety (FOS), vegetation indices (VI) and rainfall data on 18th February 2024

Fig. 14. Factor of safety (FOS), vegetation indices (VI) and rainfall data on 18th March 2024
